Situation Photo Log

Wednesday, June 6, 2012

Kalamazoo River / Enbridge Spill

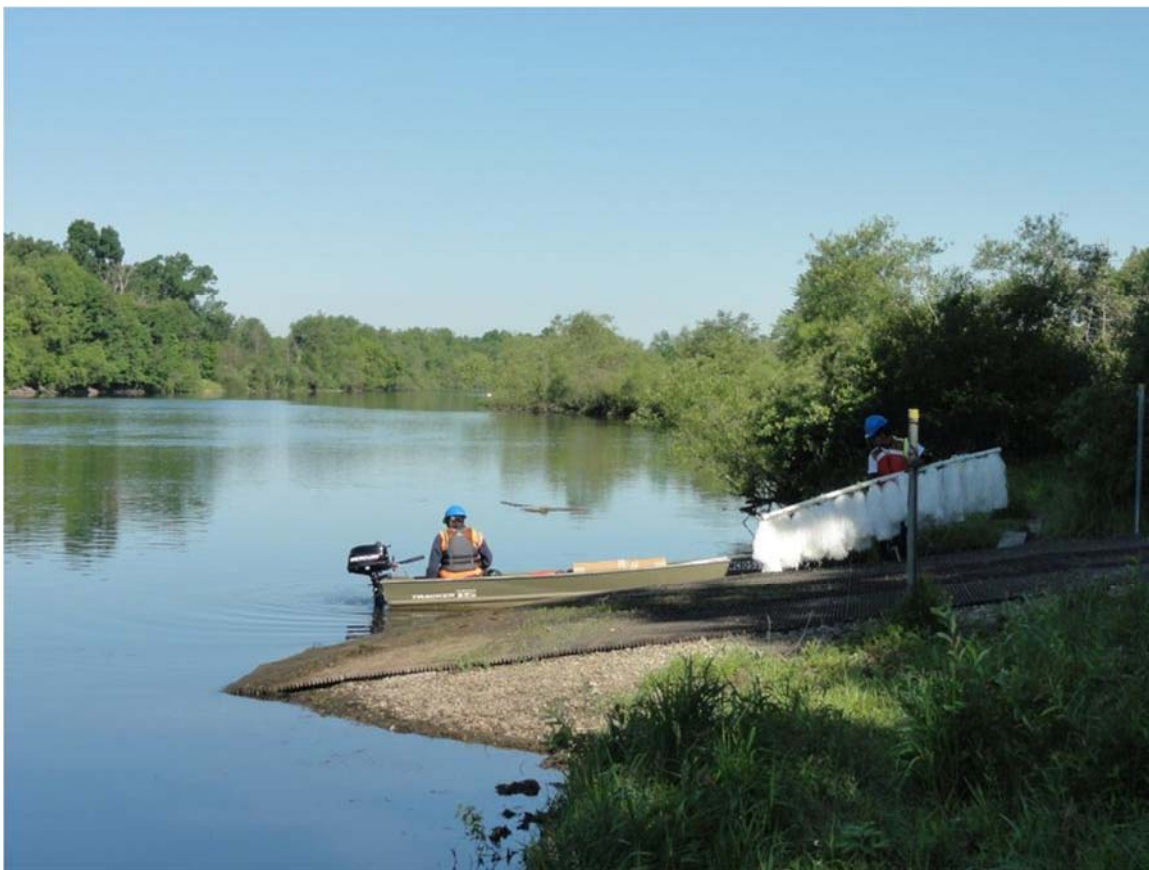
1. C0.4 Boat Launch sweep boat crew preparing to go down to the dam.

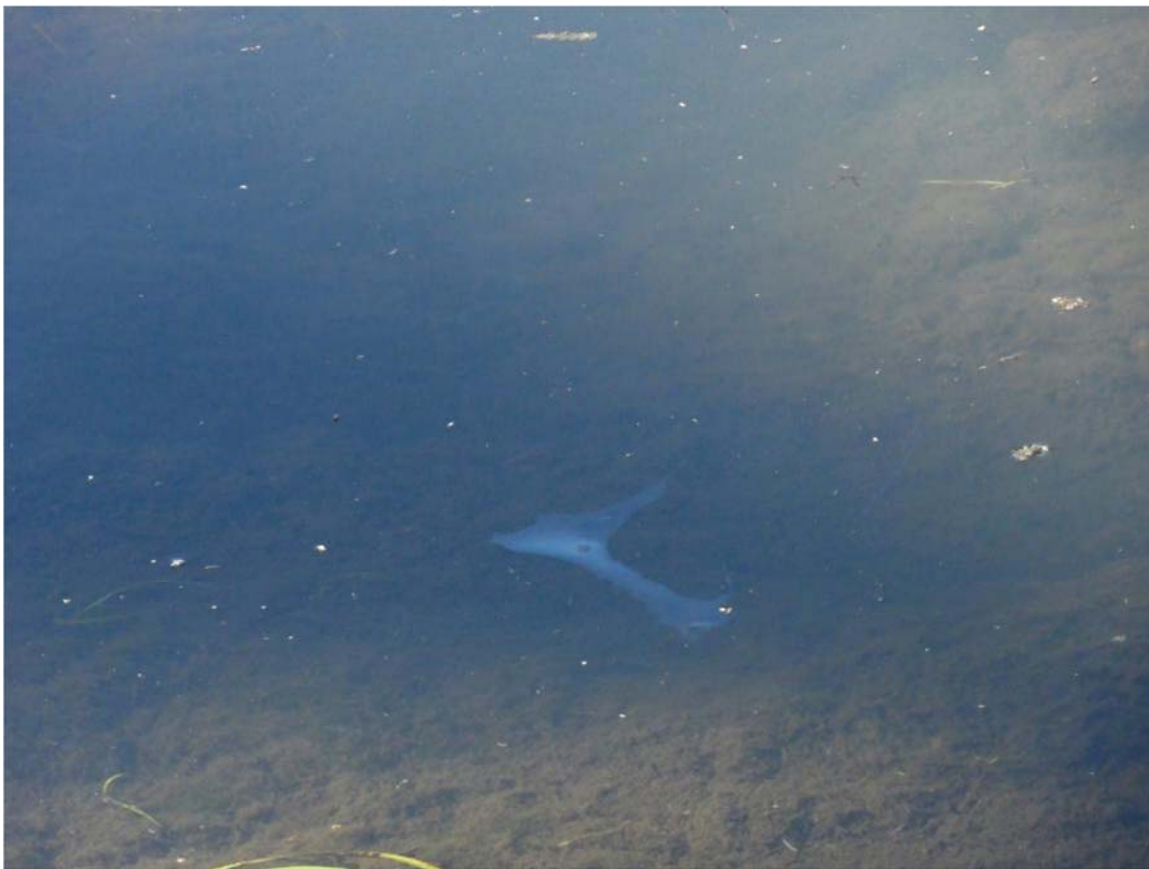
2. Sheen observed at C0.4 boat launch.

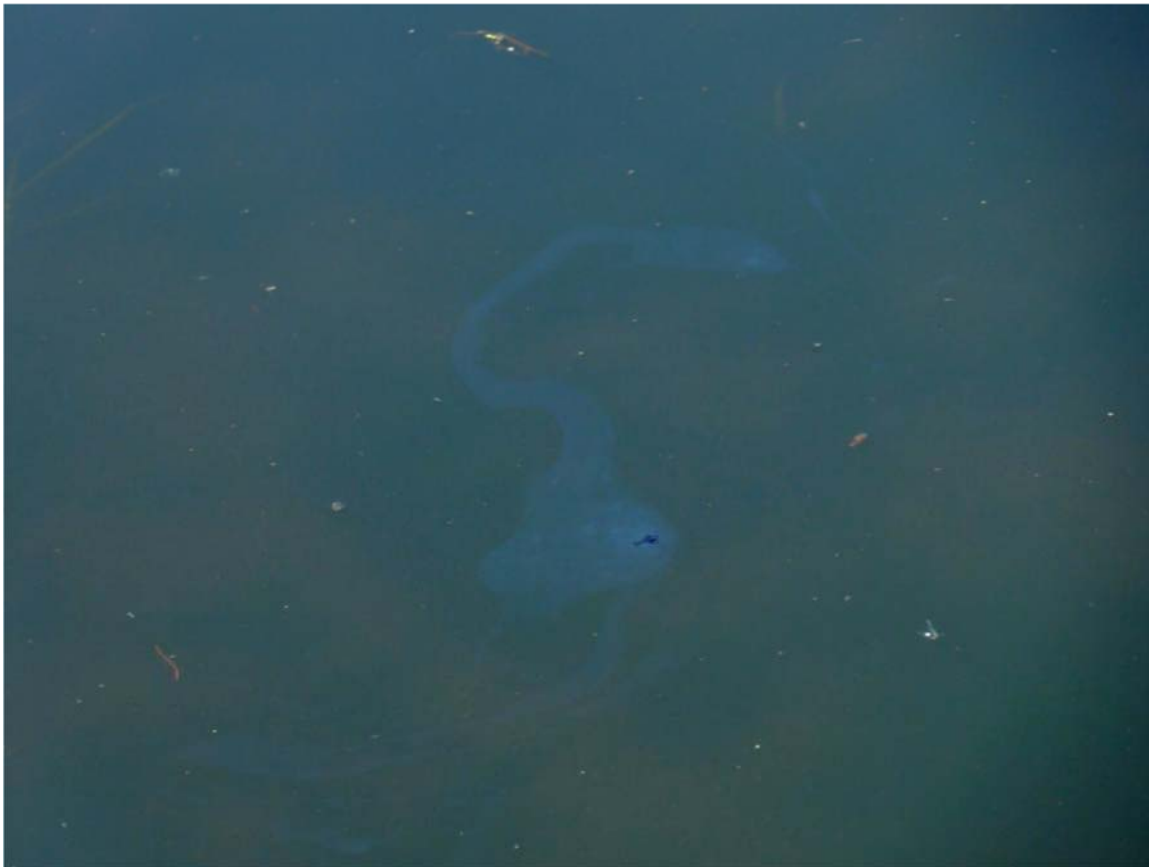
3. Tar glob and sheen observed along the Ceresco Dam boom.

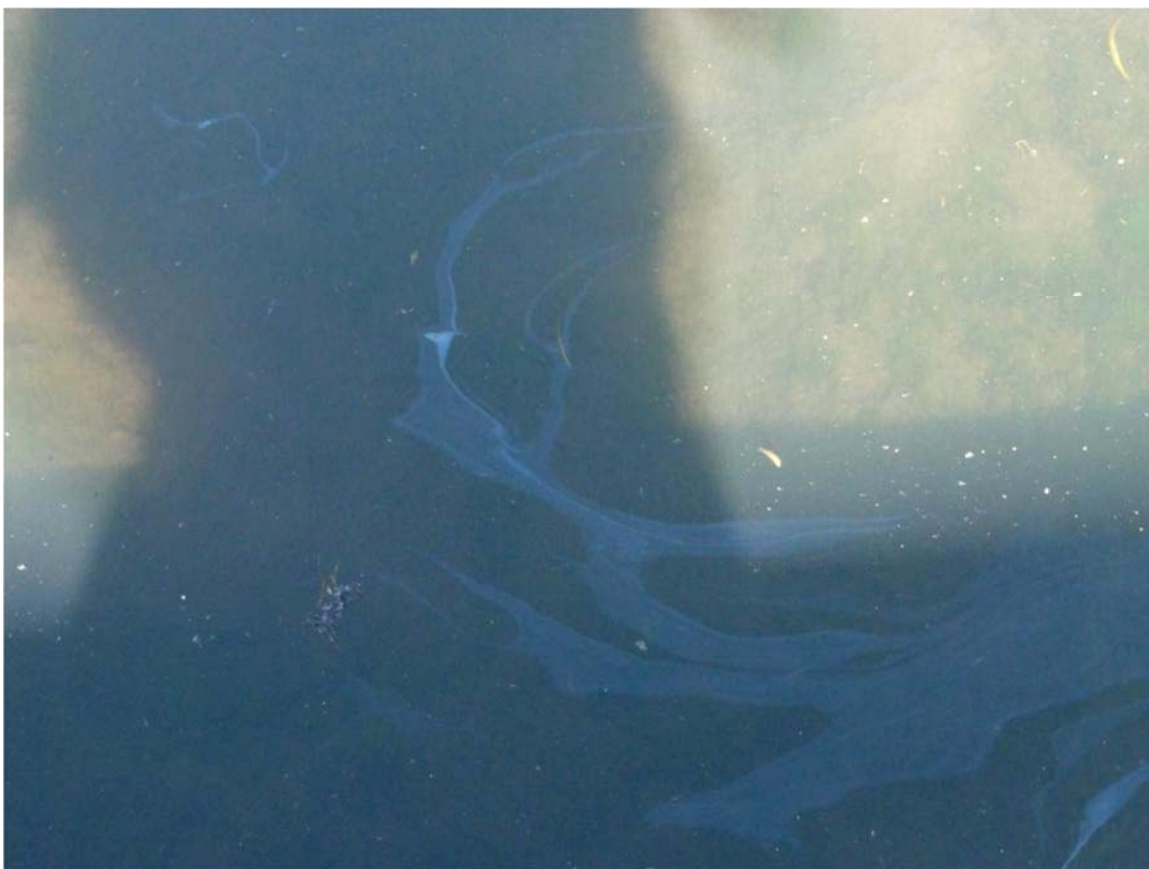
4. Sheen observed along the Ceresco Dam boom.

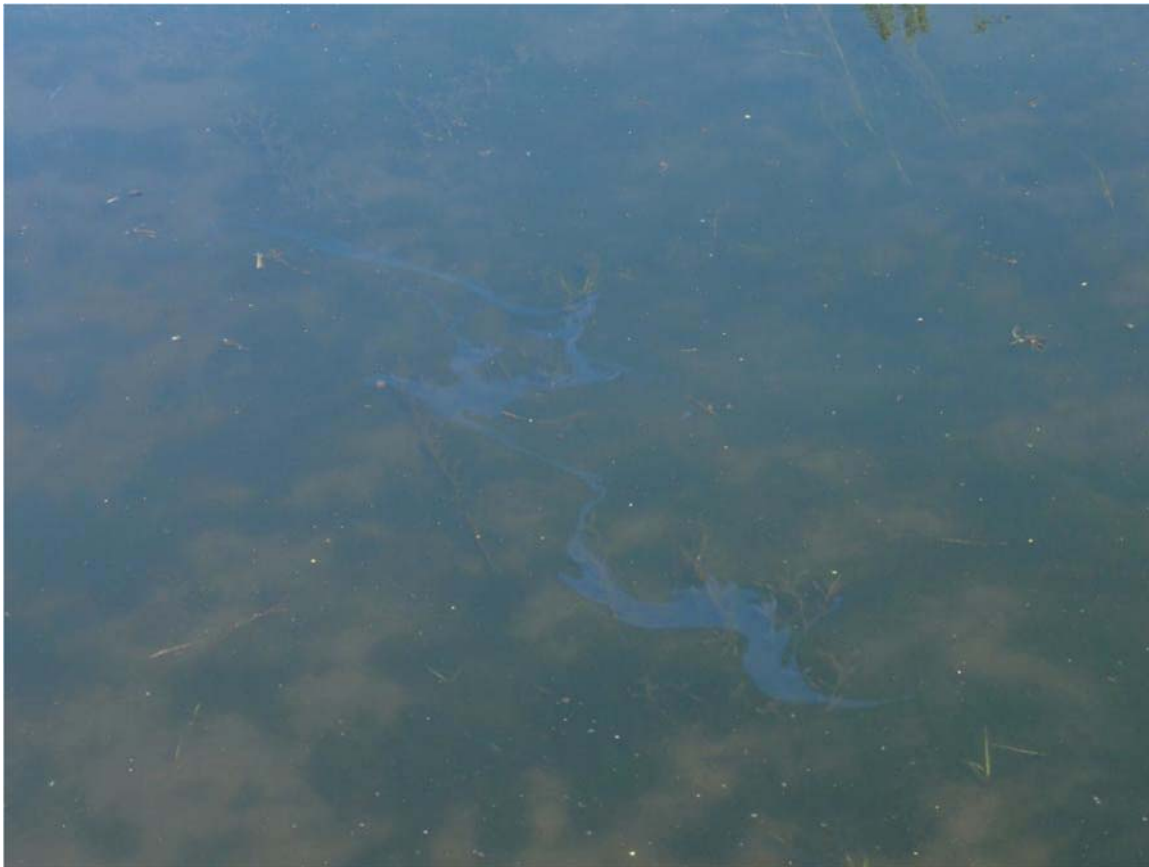
5. Sheen observed along the Ceresco Dam boom.

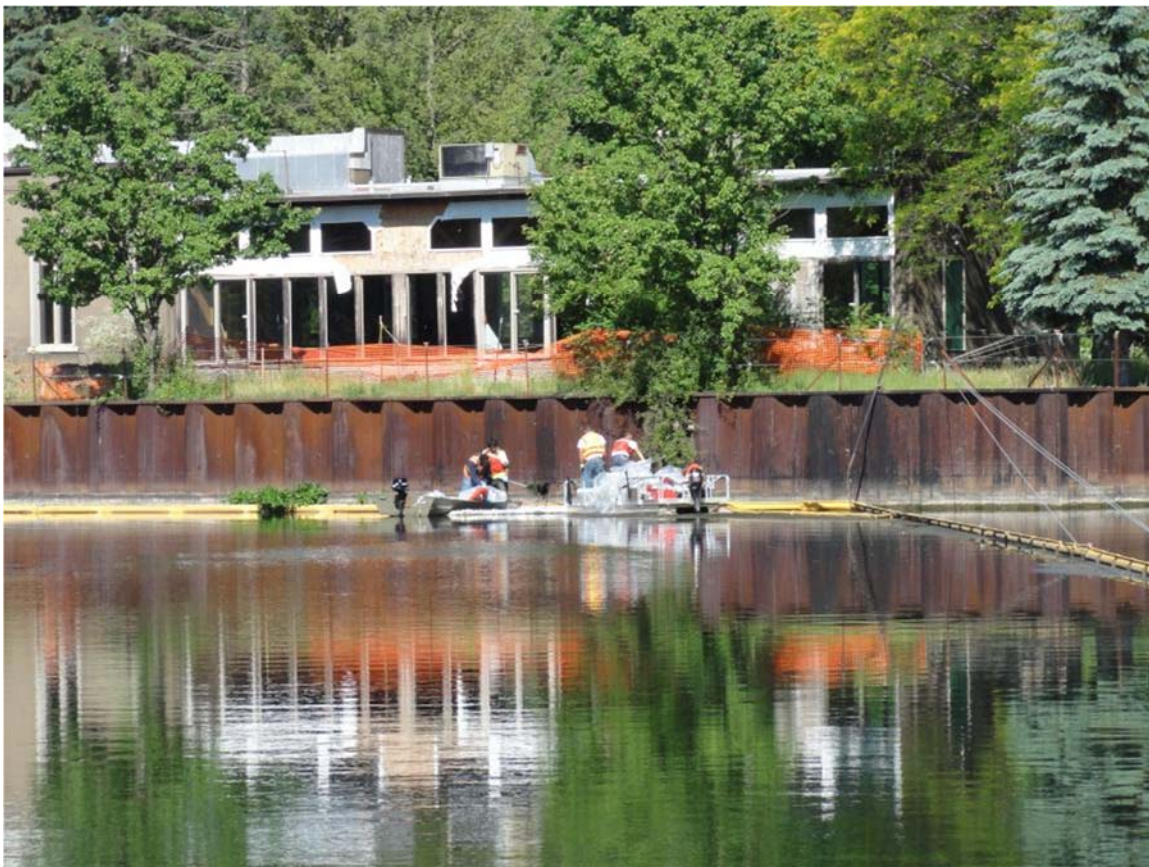
6. Ceresco Dam crew observed performing boom maintenance.

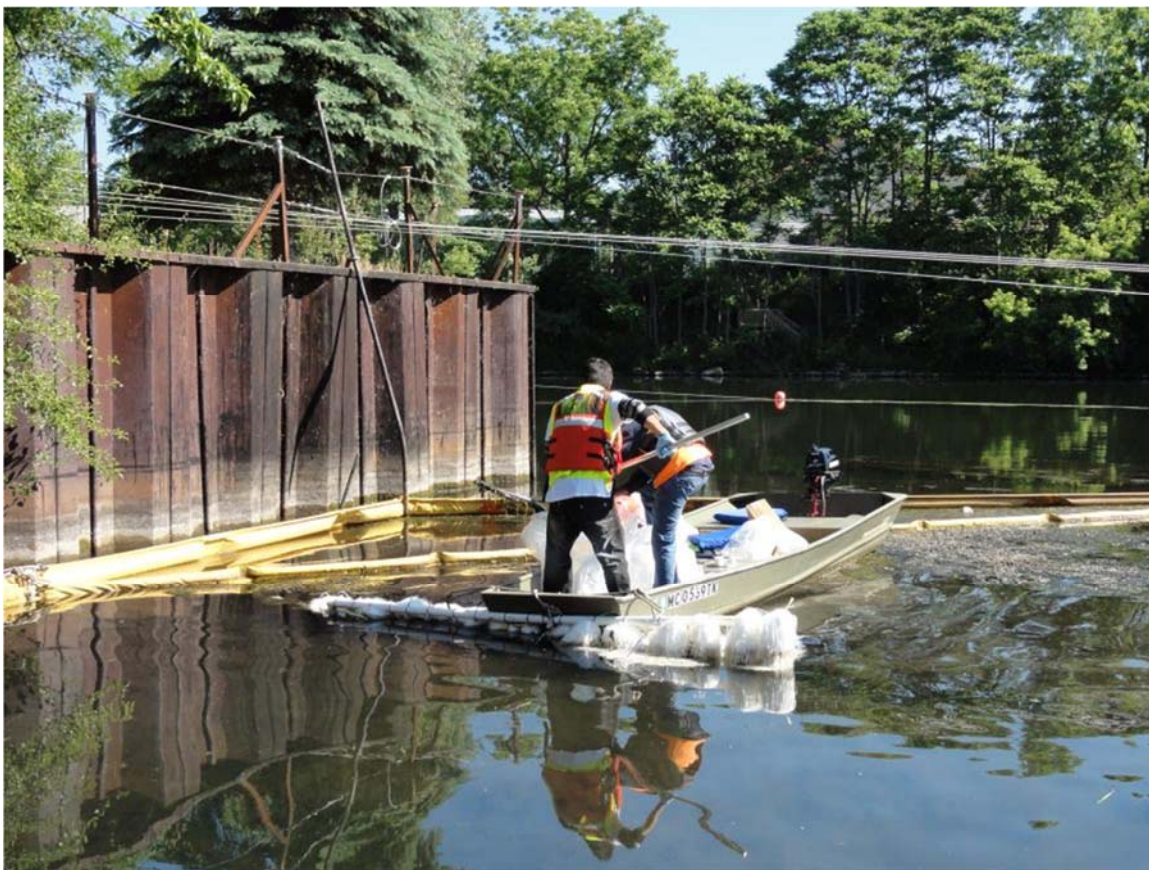
7. Ceresco Dam crew observed performing boom maintenance.

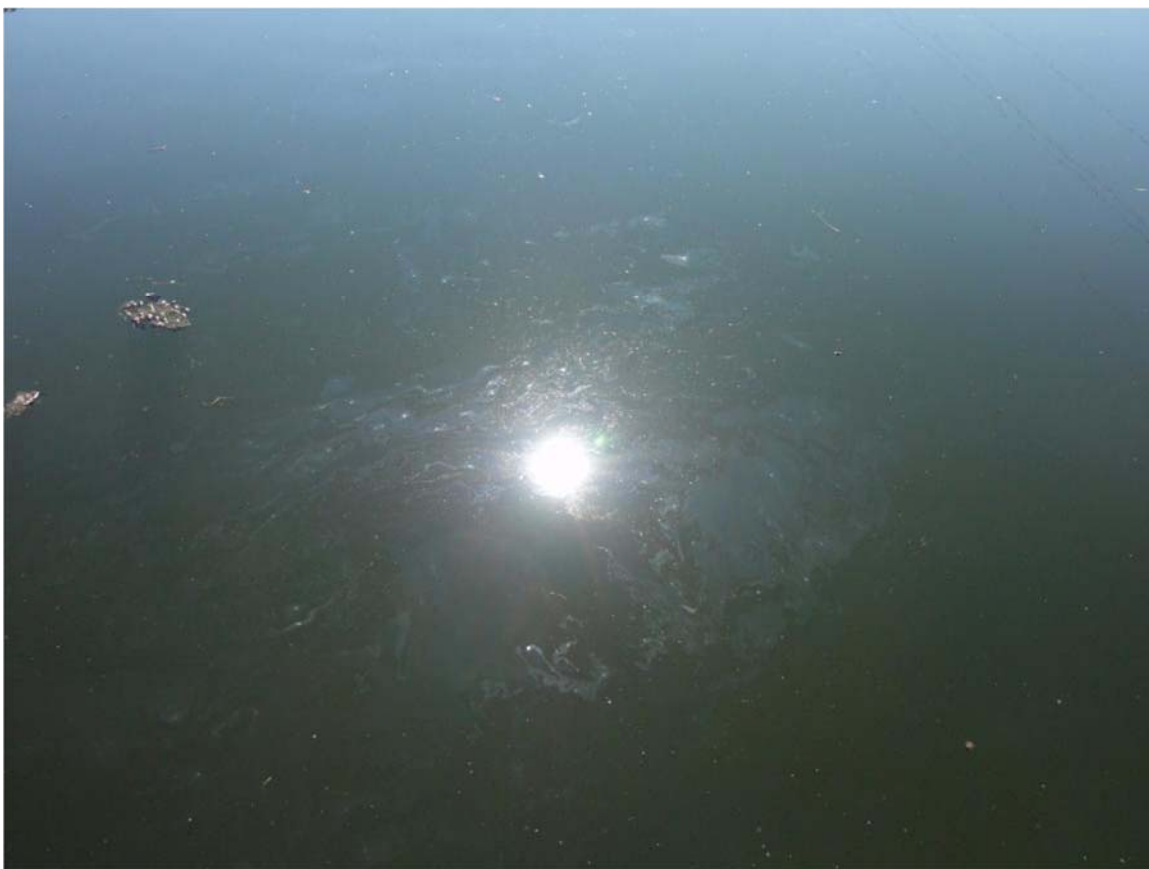
8. MP5.63 LDB near peninsula sheen observed.

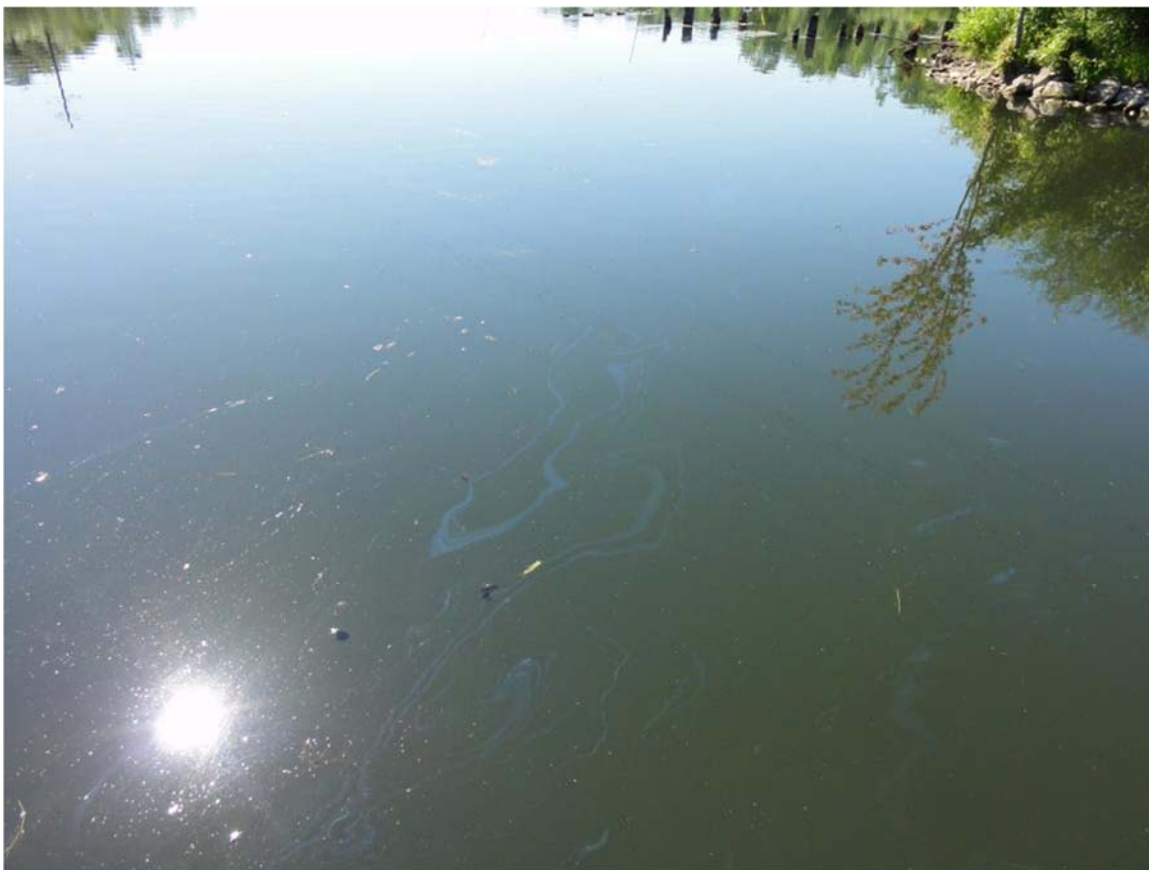
9. MP5.63 LDB near peninsula sheen observed.

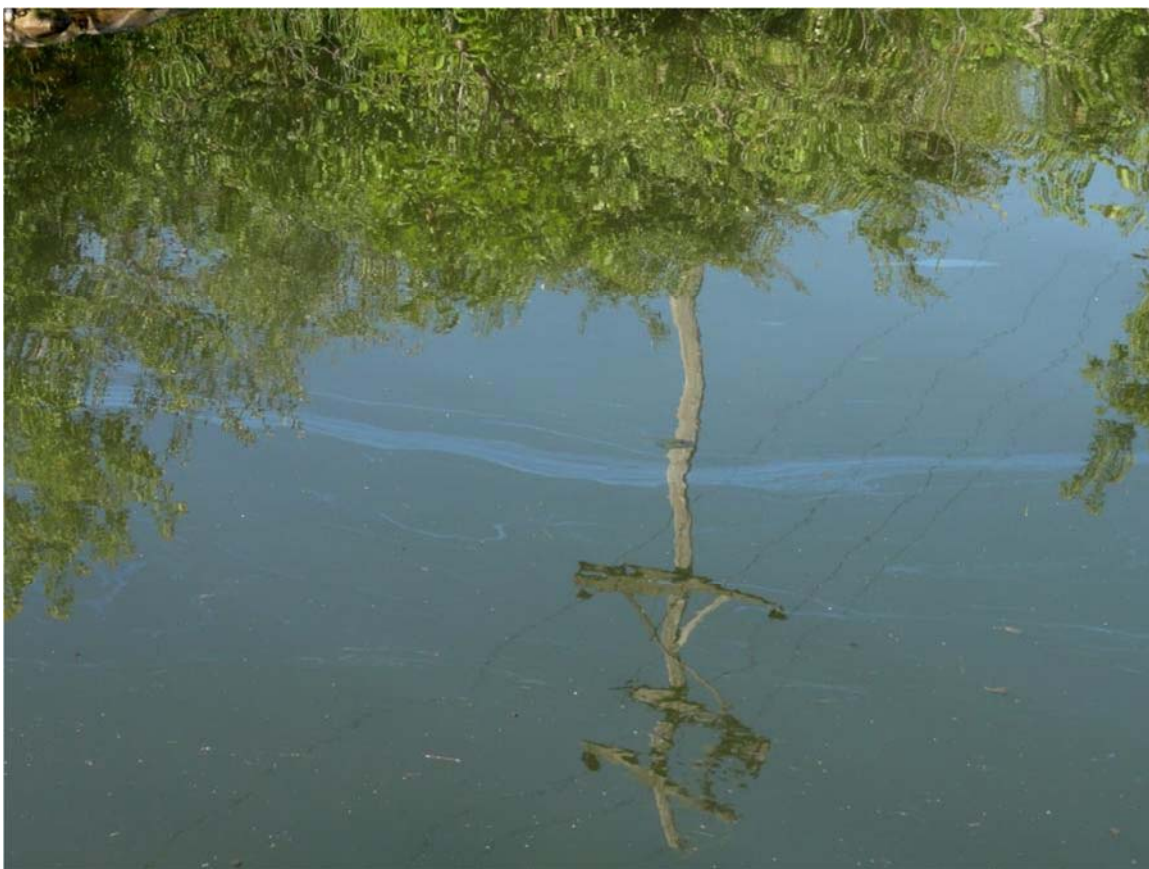
10. MP5.63 LDB near peninsula sheen observed.

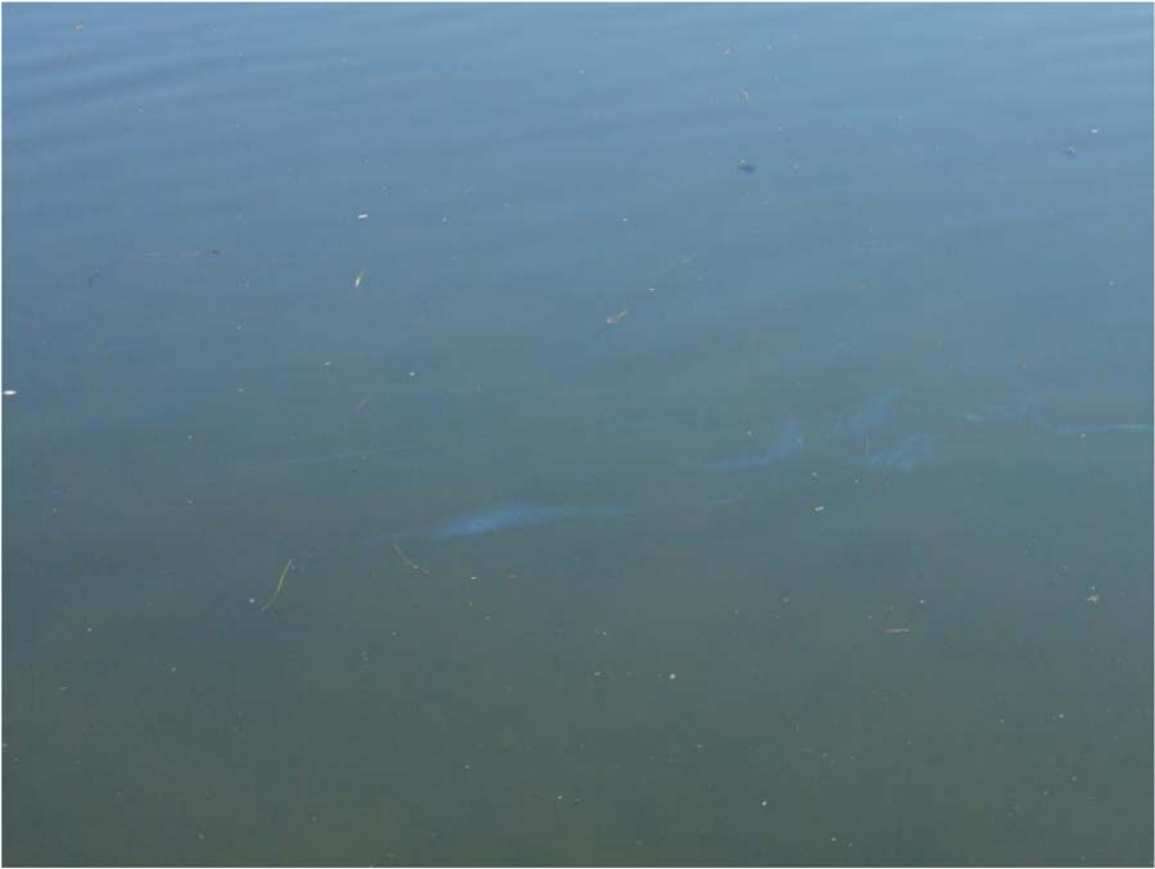
11. MP5.55 LDB sheen observed.

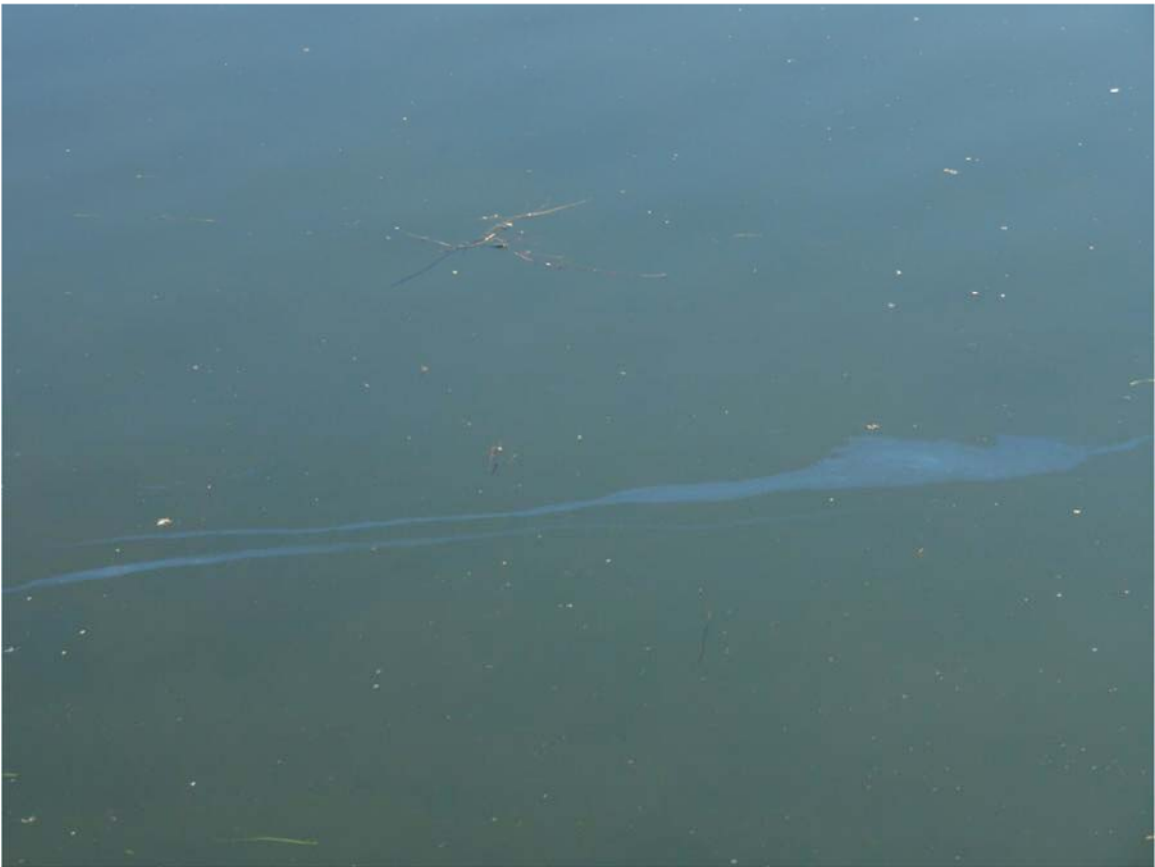
12. MP5.55 LDB sheen observed.

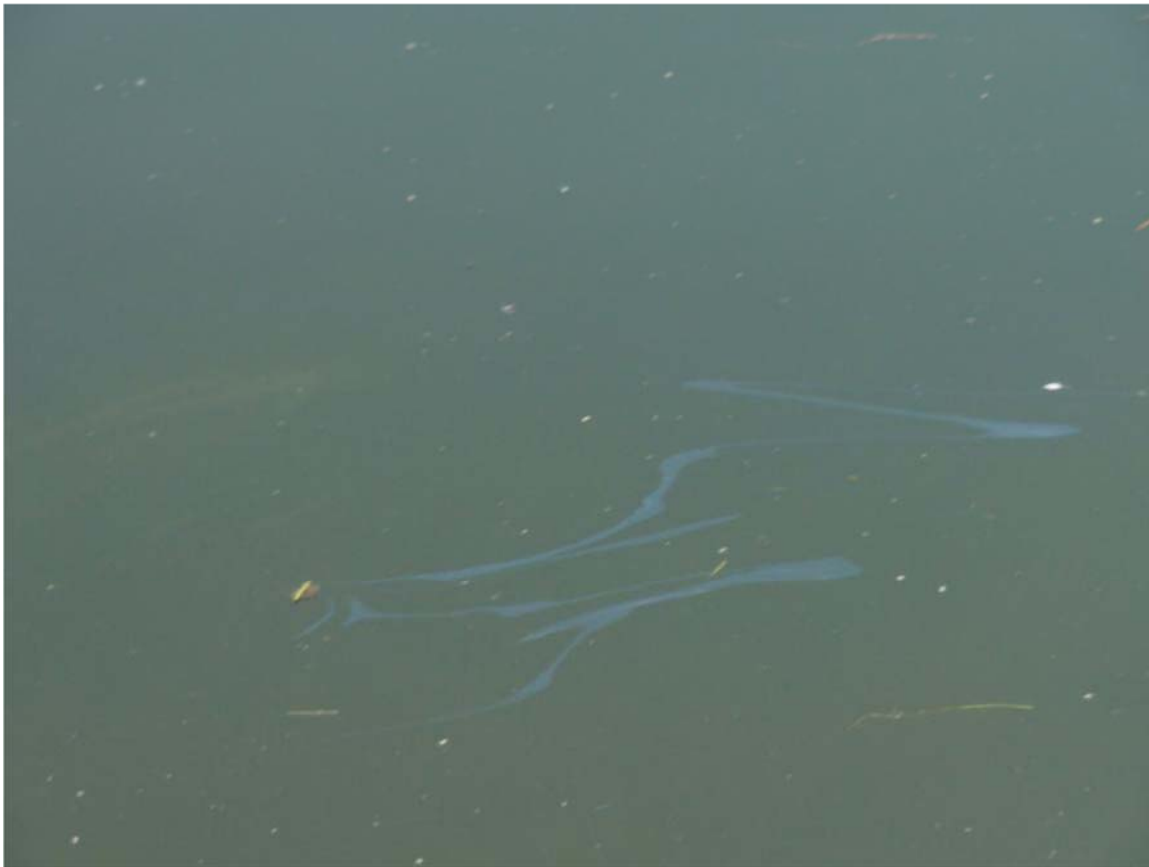
13. MP5.5 LDB sheen observed.

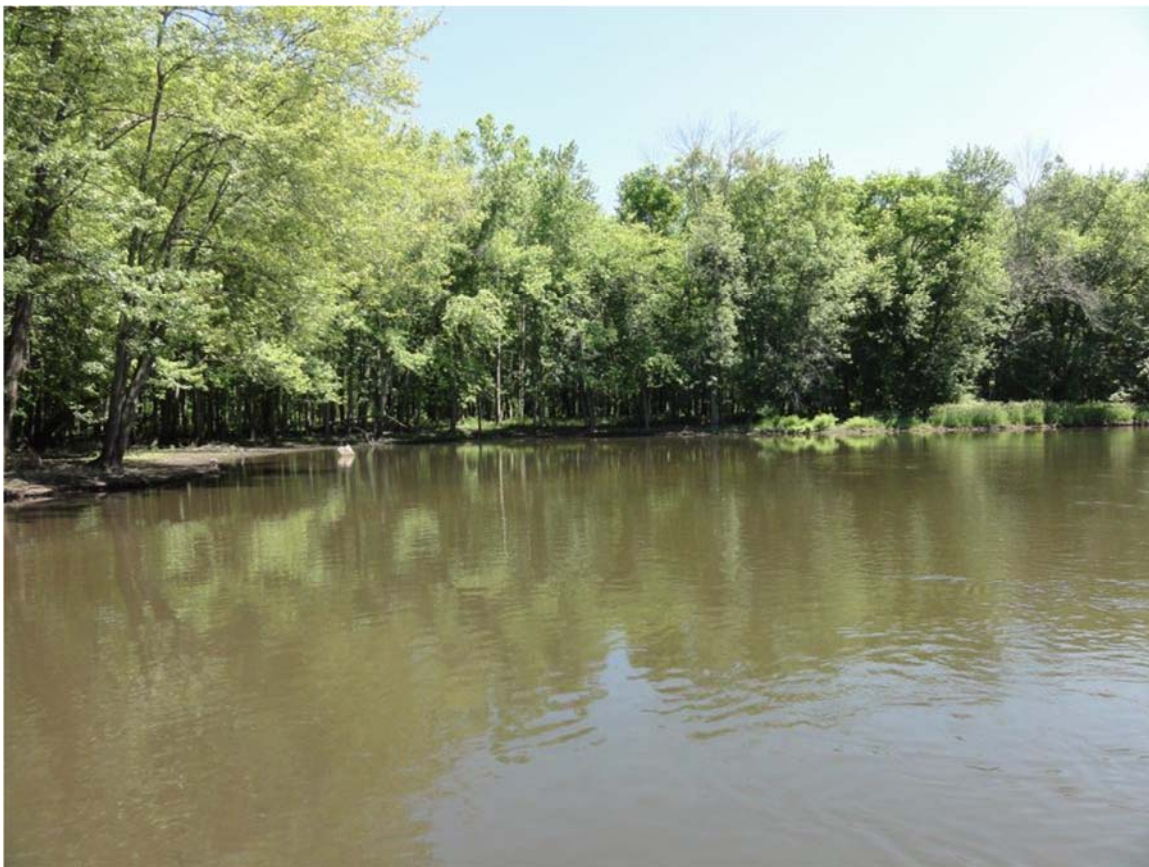
14. MP27.75 LDB, sheen observed.

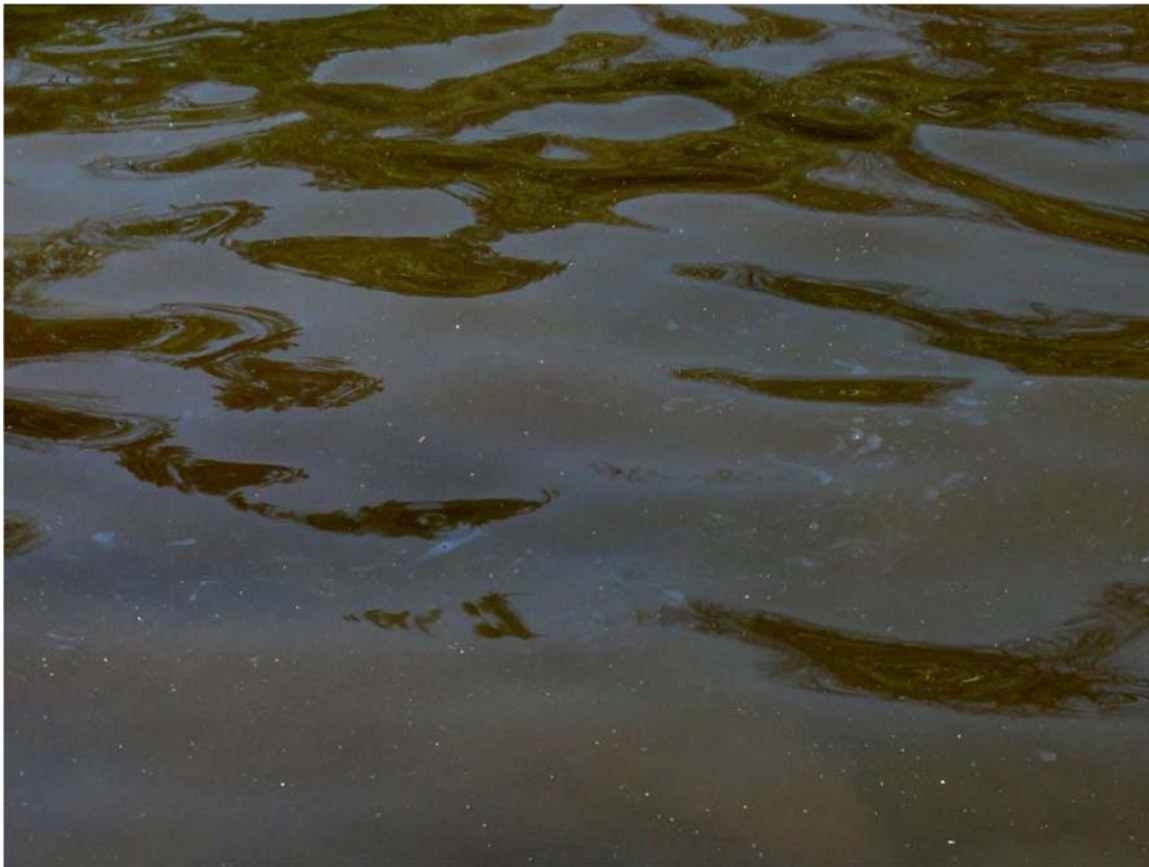
15. MP27.75 LDB, sheen observed.

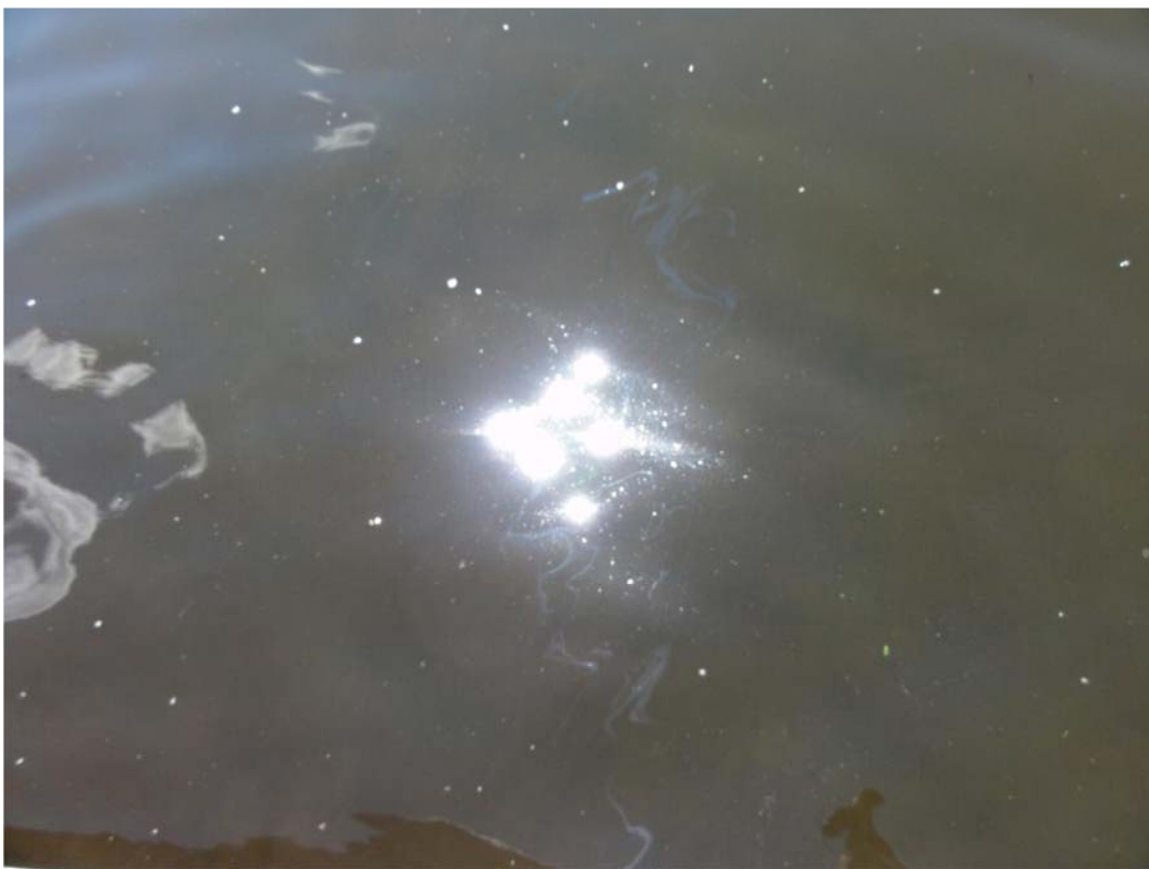
16. MP27.75 LDB, sheen observed.

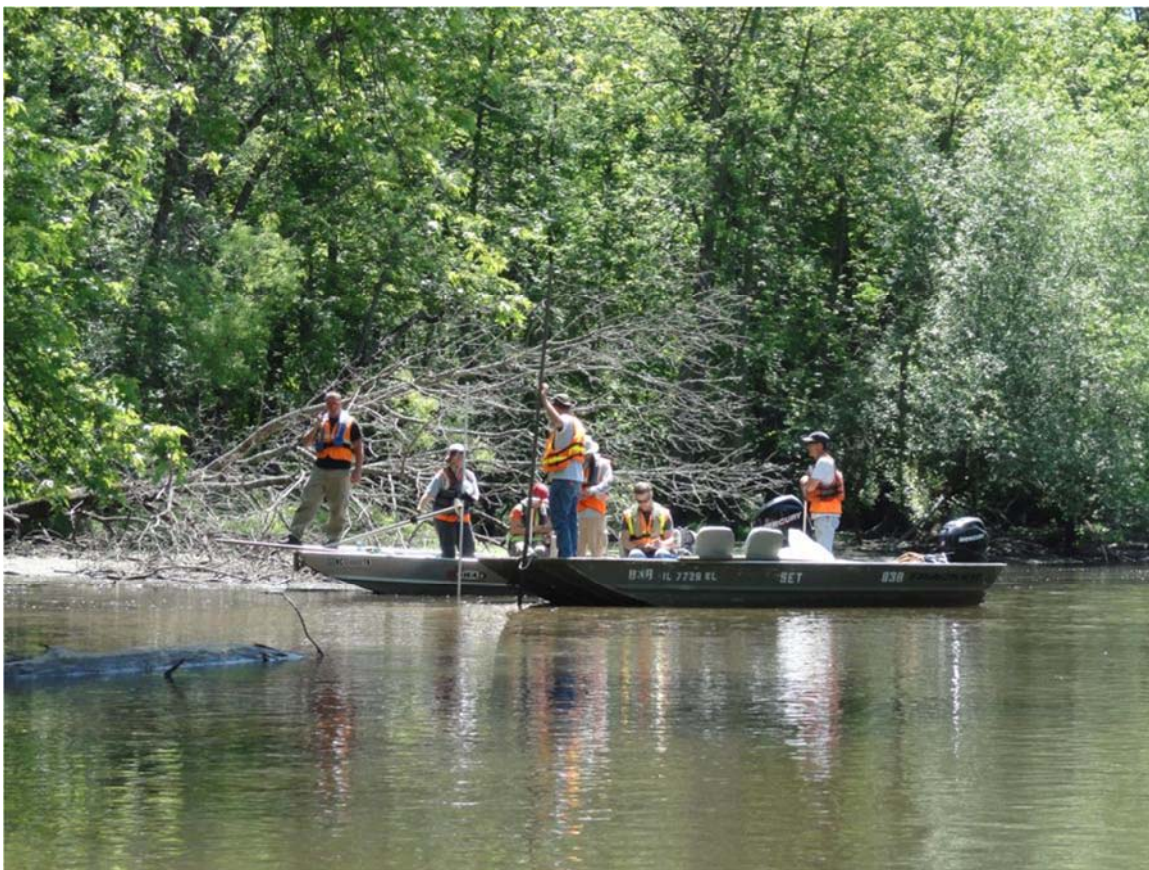
17. MP30.0 LDB poling crew observed.

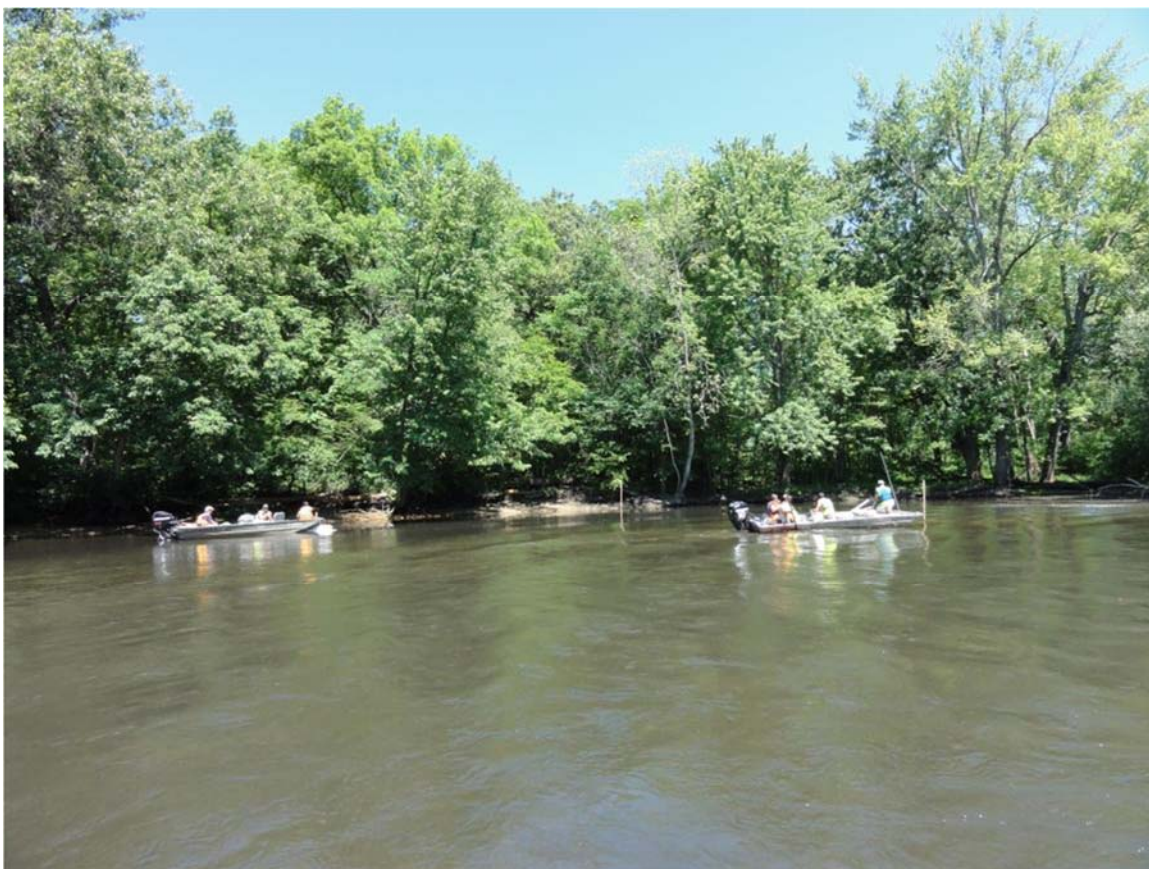
18. MP30.25 RDB poling crew observed.

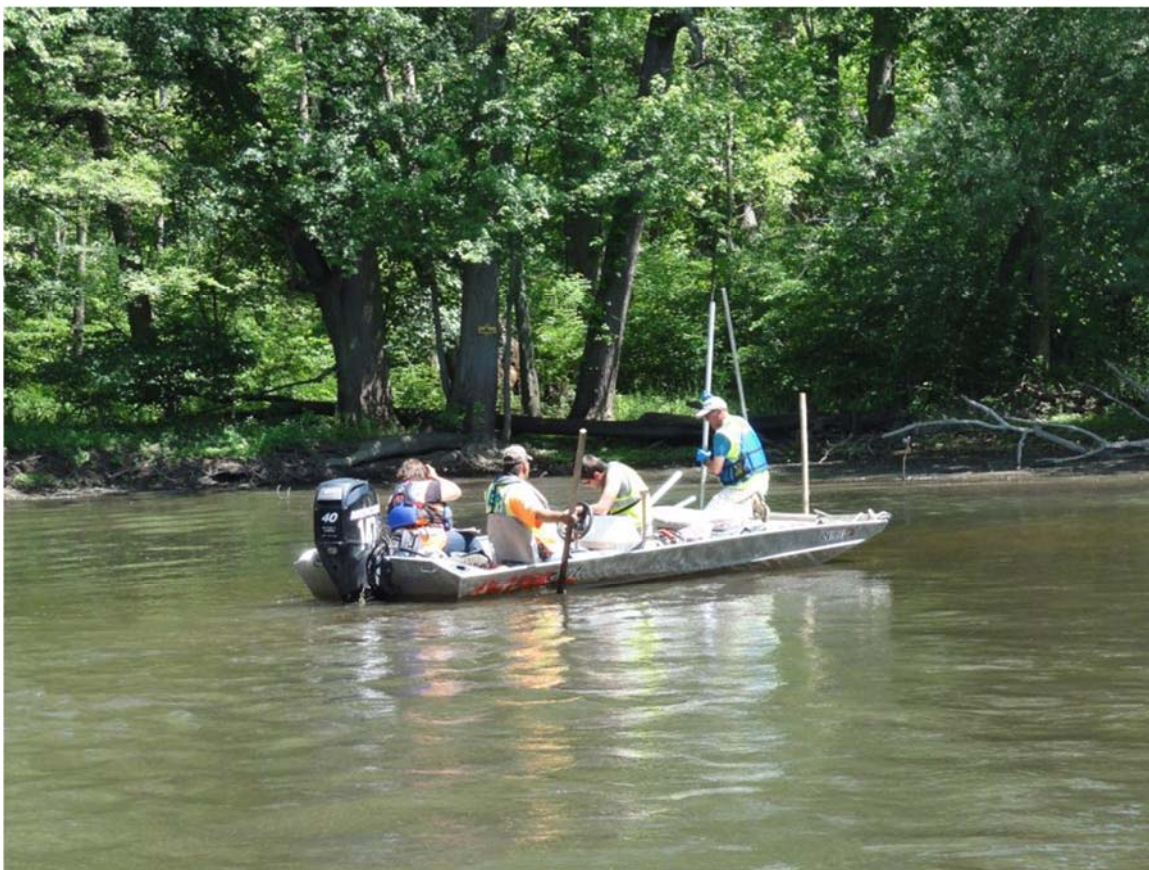
19. MP30.25 RDB poling crew observed.

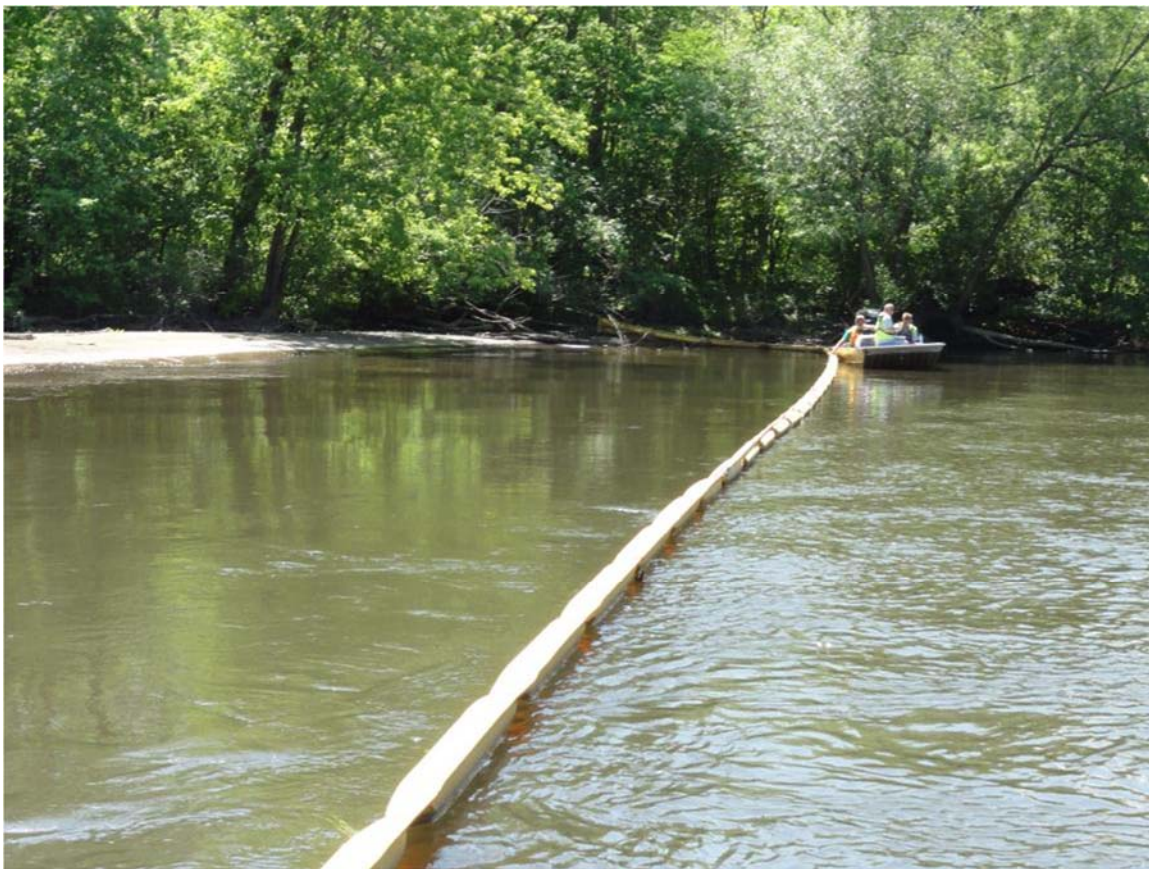
20. MP30.8 Containment branch crew observed.

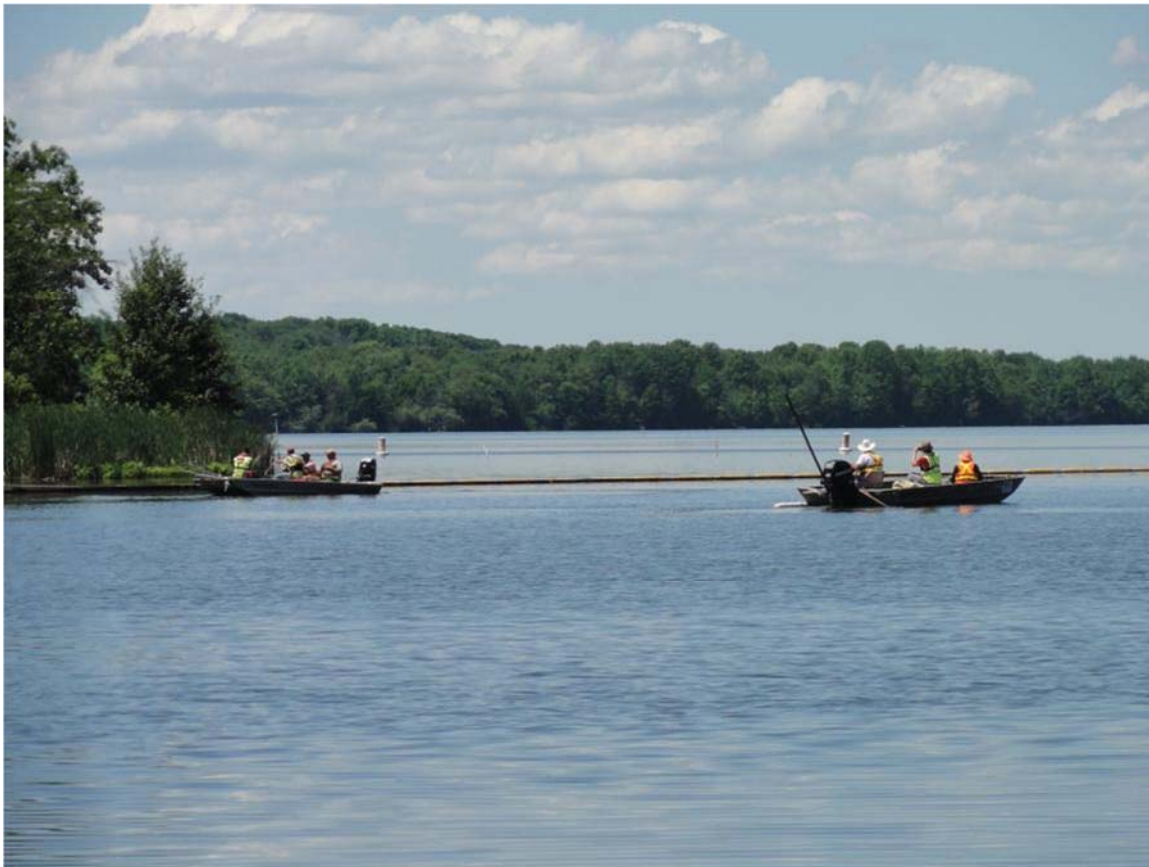
21. MP37.75 Poling crew observed.

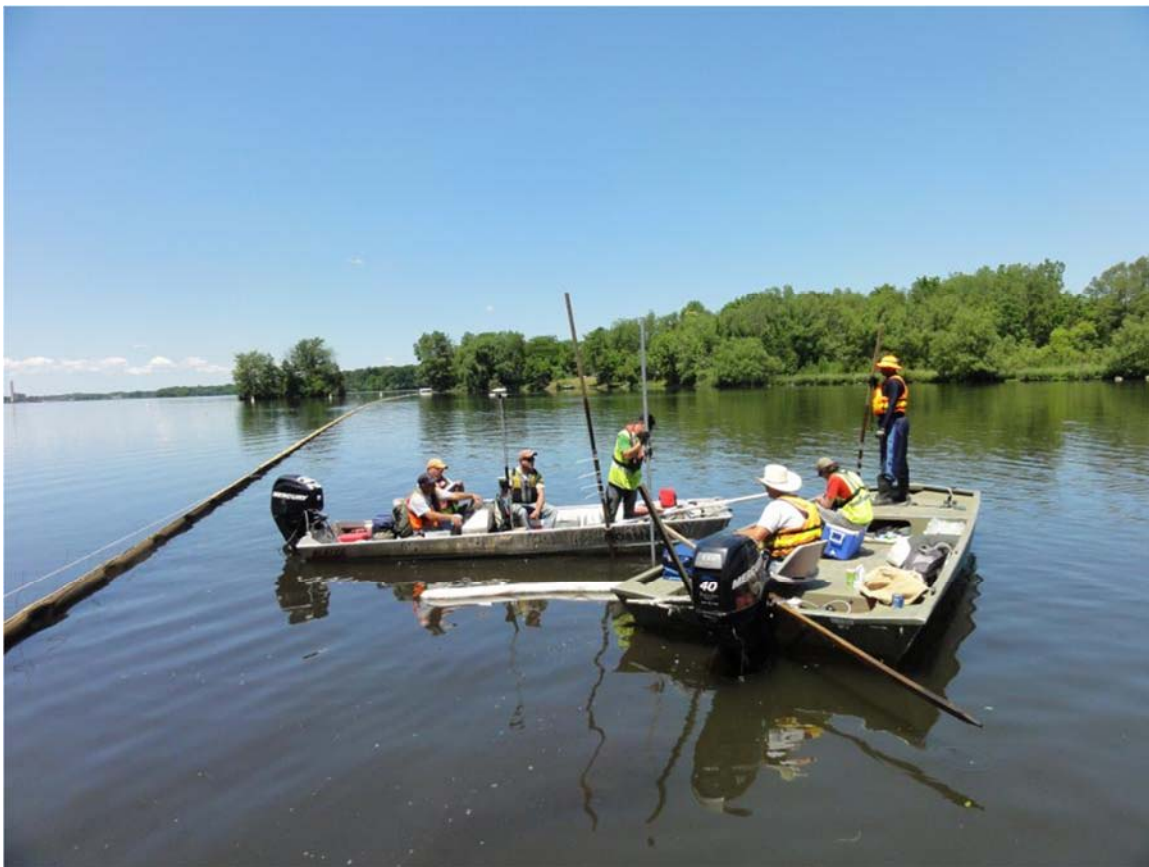
22. MP37.75 Poling crew observed.

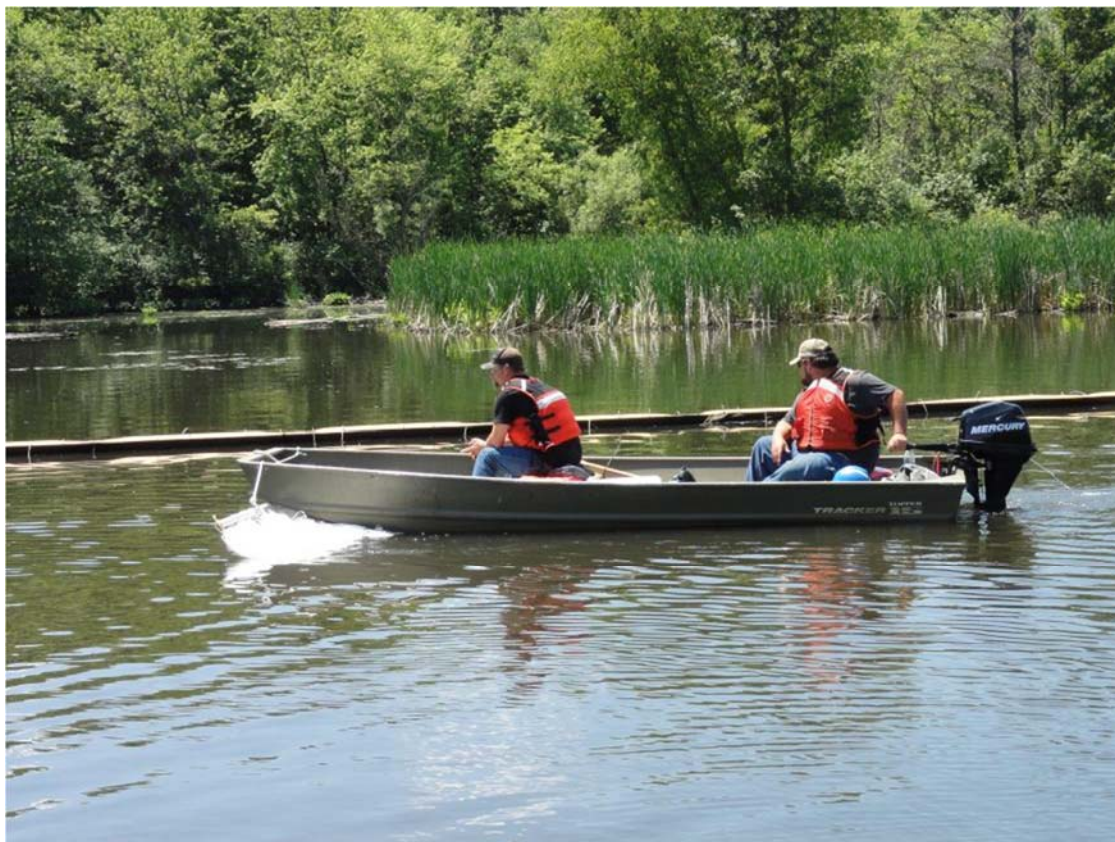
23. Sheen sweep boat observed operating along the E4 boom.
